SUBJECT: ON-SCENE COORDINATOR'S REPORT - Removal Action at the Dayton Tire and Rubber Co. Site, Phase II and III, Dayton, Montgomery County, Ohio (Site ID # 9A)

ON-SCENE COORDINATOR'S REPORT

**DAYTON TIRE AND RUBBER COMPANY
PHASES II AND III
DAYTON, OHIO**

DELIVERY ORDER NO. 7460-05-107

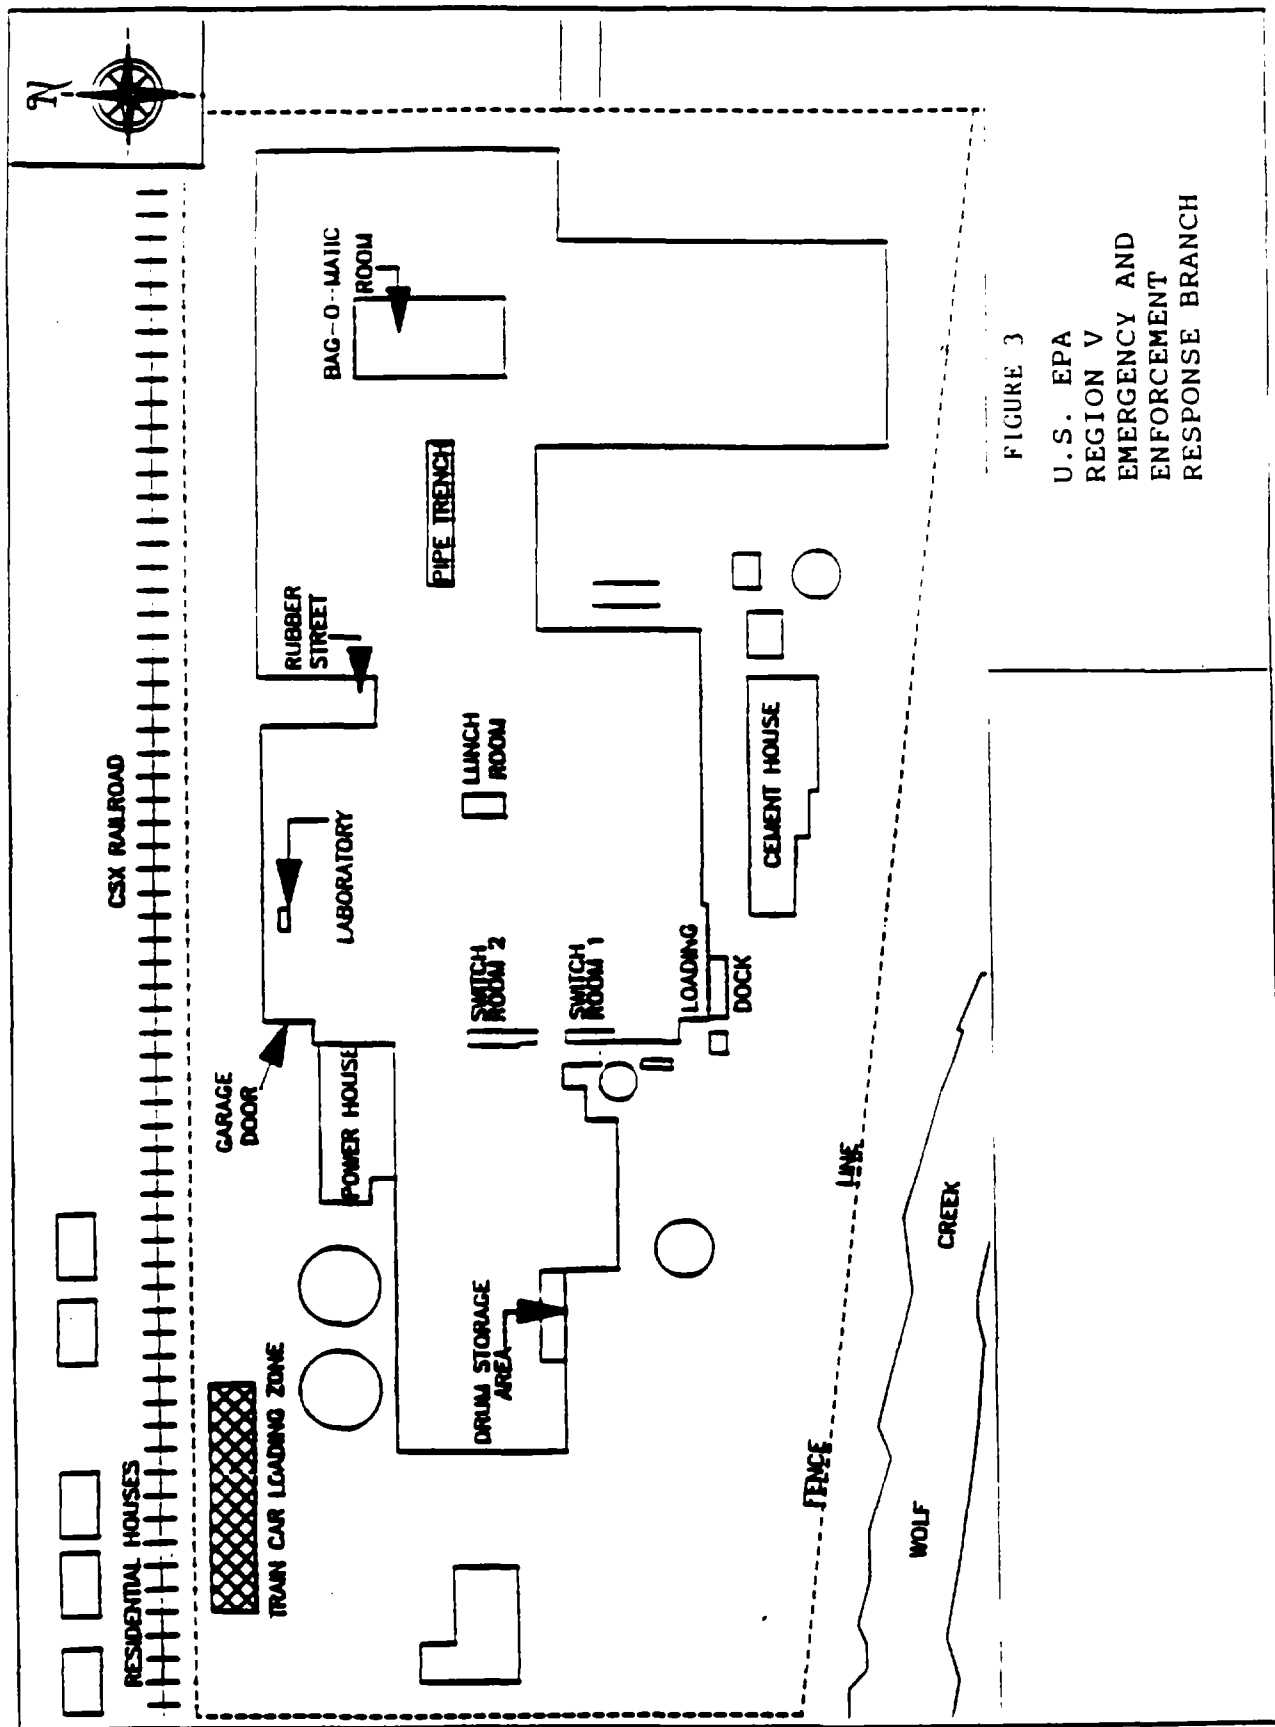
FIGURE 3
U.S. EPA
REGION V
EMERGENCY AND
ENFORCEMENT
RESPONSE BRANCH

The dominant structure at the Dayton Tire site is a one- to four-story abandoned building, hereinafter referred to as the "Facility." The Facility (1,600 feet long and 800 feet wide) was the predominant area of tire manufacturing, storage, and processing at the Dayton Tire site (Figure 3). A basement level is situated beneath approximately two-thirds of the structure (Figure 4). A pump station on the south side of the Facility drains the area around and beneath the Facility (Figure 2).

PCB contamination in the DTR main building initially occurred in isolated areas where copper scavengers spilled PCB-contaminated oil from electrical transformers. The PCB contamination was concentrated inside the electrical transformer storage vaults and electrical switch rooms (Figures 3 and 4). Widespread PCB contamination from these isolated source areas subsequently resulted via tracking and flooding. Analytical results of a surface extent-of-contamination study indicated PCB levels between 500 and 1,000 ug/cm² in the areas where the PCB-contaminated oil was initially spilled, and between 10 and 100 ug/cm² along pathways radiating from the original contamination areas (PEI, 1988). Procedures implemented to clean the PCB-contaminated floor surfaces during the Phase II removal action included scabbling, shot-blasting, and solvent extraction. Because of the large area of floors contaminated with PCBs, however, these methods were very costly and time-consuming.
